3D RADAR

US 25 E KNOX/LAUREL CO

WATER BLEEDING – PAVEMENT INVESTIGATION

PRELIMINARY FINDINGS

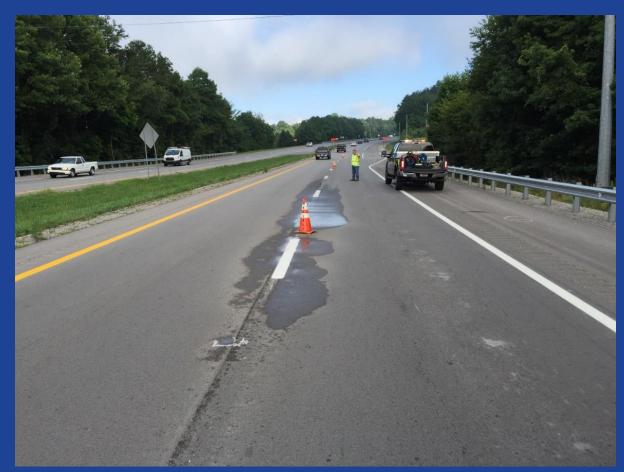
NB SITE 1 – MP 24.4

- Water bleeding up through longitudinal joint
- Slight super, high side left shoulder
- 9 Perms
 - 4 on joint
 - 3 six inches left of joint
 - 2 six inches right of joint
- 3 cores
 - Left of joint
 - Right of joint
 - On joint

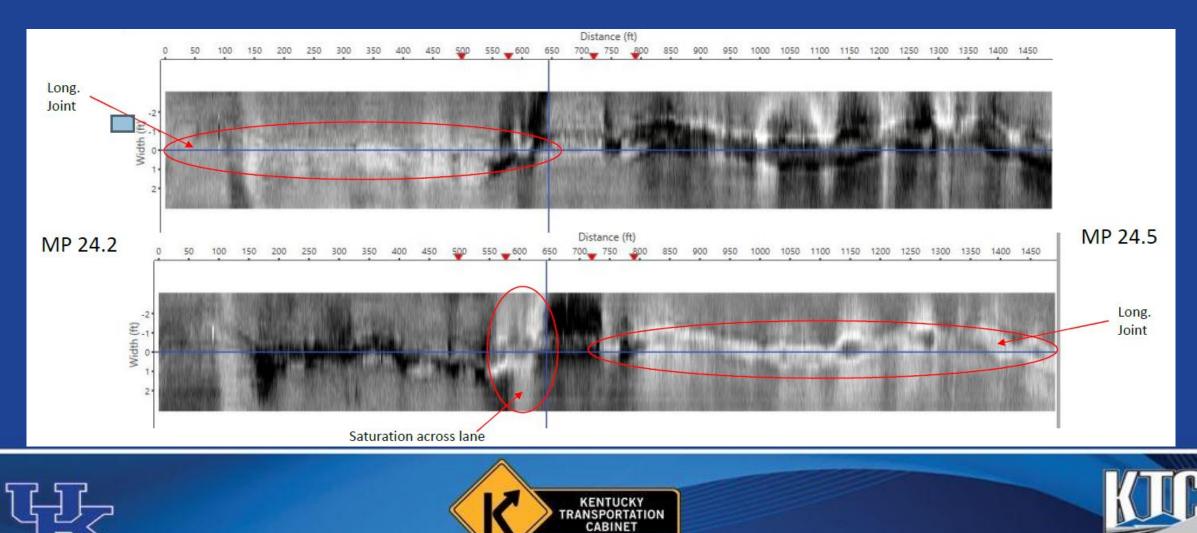
NB SITE 1 - 3D GPR SCAN OF LONGITUDINAL JOINT MP 24.2 TO MP 24.5

- Top down slice of 3D scan
- First Image shows moisture at 5.5" and second image shows moisture at 5"
- Joint appears saturated, some saturation across the lane

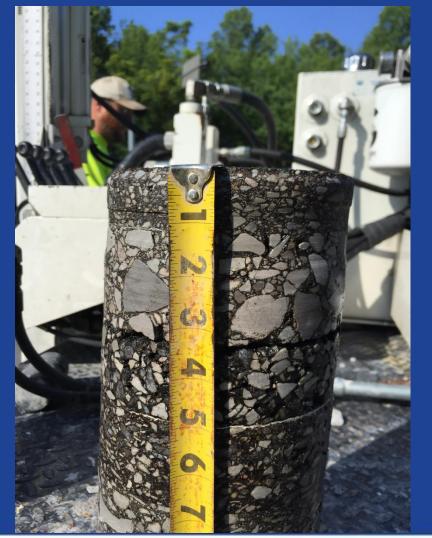
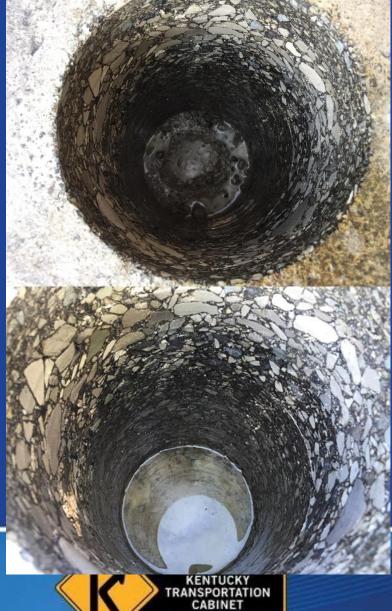
NB SITE 1 – CORE 1 (ON JOINT)

- Cored to top of DGA
- Dried out core hole
- After a few minutes there was an inch of water in the core hole
- Debonding at old and new pavement at ~ 3.5"
- Water appears to be coming in through Old/New interface as can be seen from the pictures

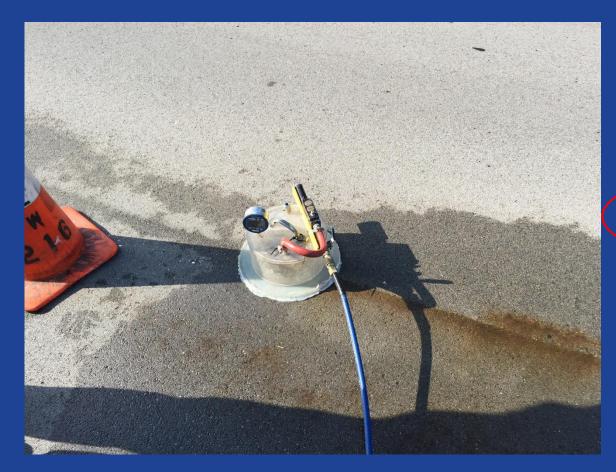
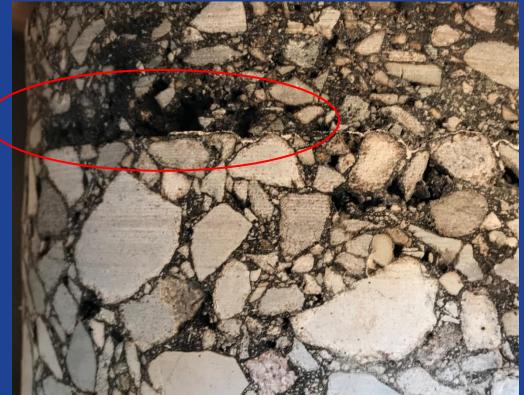
NB SITE 1 – STRIPPING

- Dark brown staining on surface possible indication of stripping
- Potential stripping at interface between new surface and new base

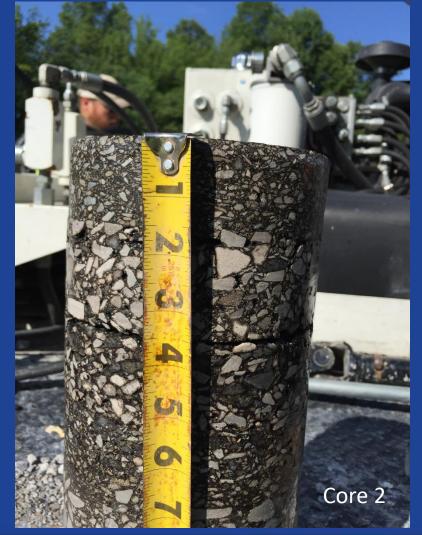
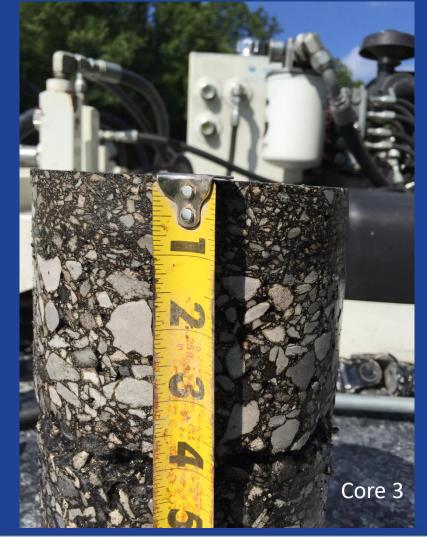
NB SITE 1 – CORE 2 (RIGHT OF JOINT) AND CORE 3 (LEFT OF JOINT)

- Cores taken 6-inches either side of the joint
- Water entering core hole at interface between new and old pavement
- Both debonded between interface between new and old pavement
 - Core 2 3.5"
 - Core 3 4.0"

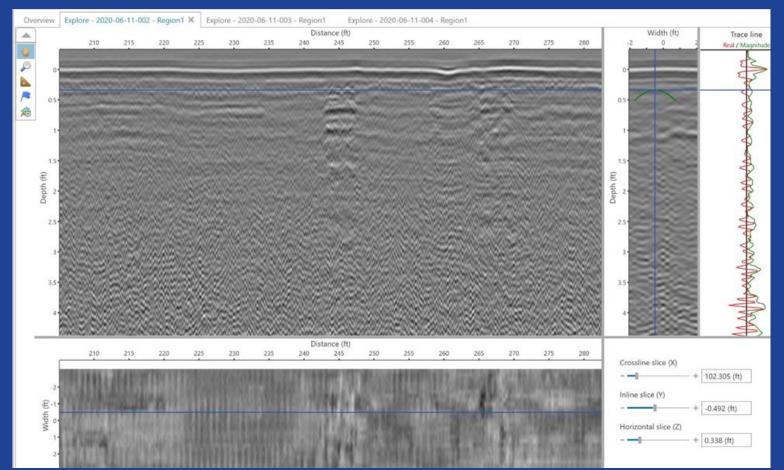
BRIDGE APPEARED TO BE DRY.
