Coreless Asphalt Pavement Compaction Assessment: Density Profiling System

Kyle Hoegh, MnDOT (presenter)

TRB 99th Annual Meeting
Asphalt Pavement Construction
and Rehabilitation Committee

Density Profiling System: Toward Coreless Continuous Compaction Assessment

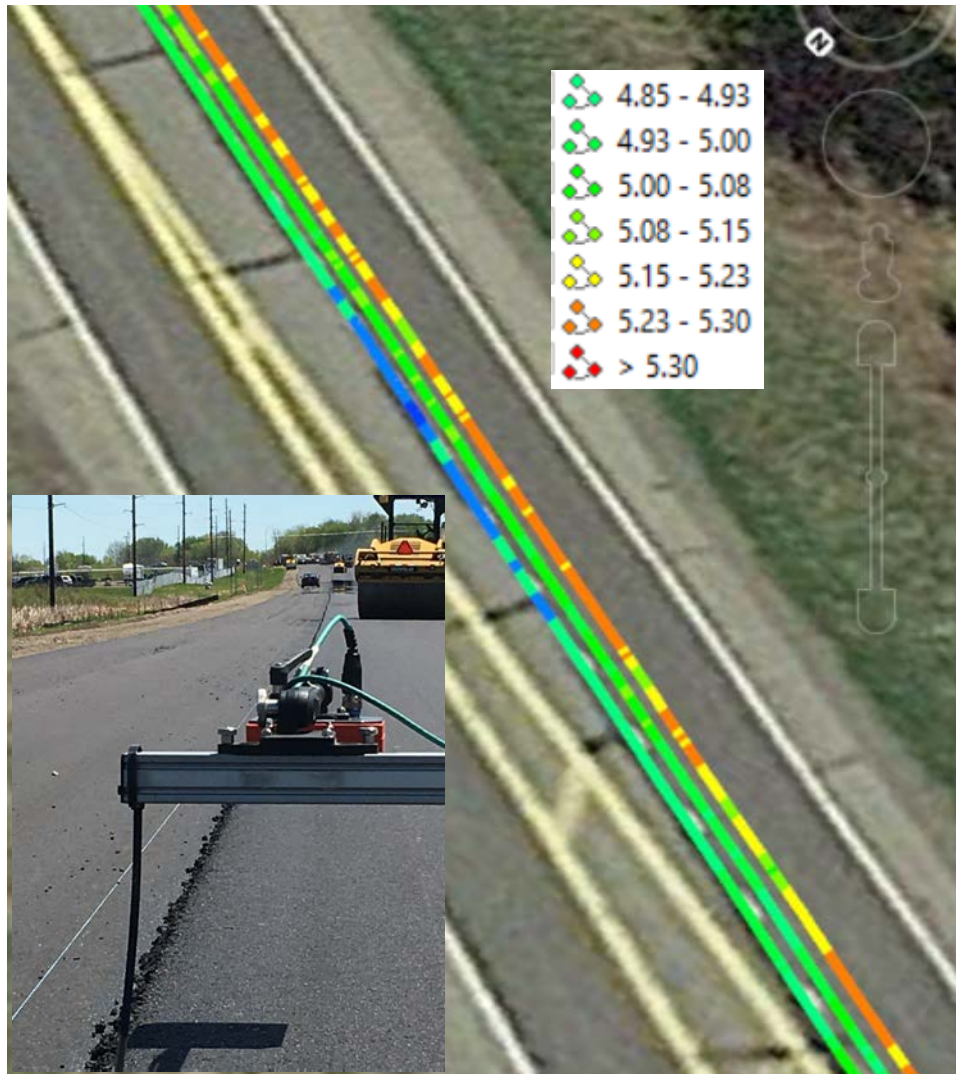
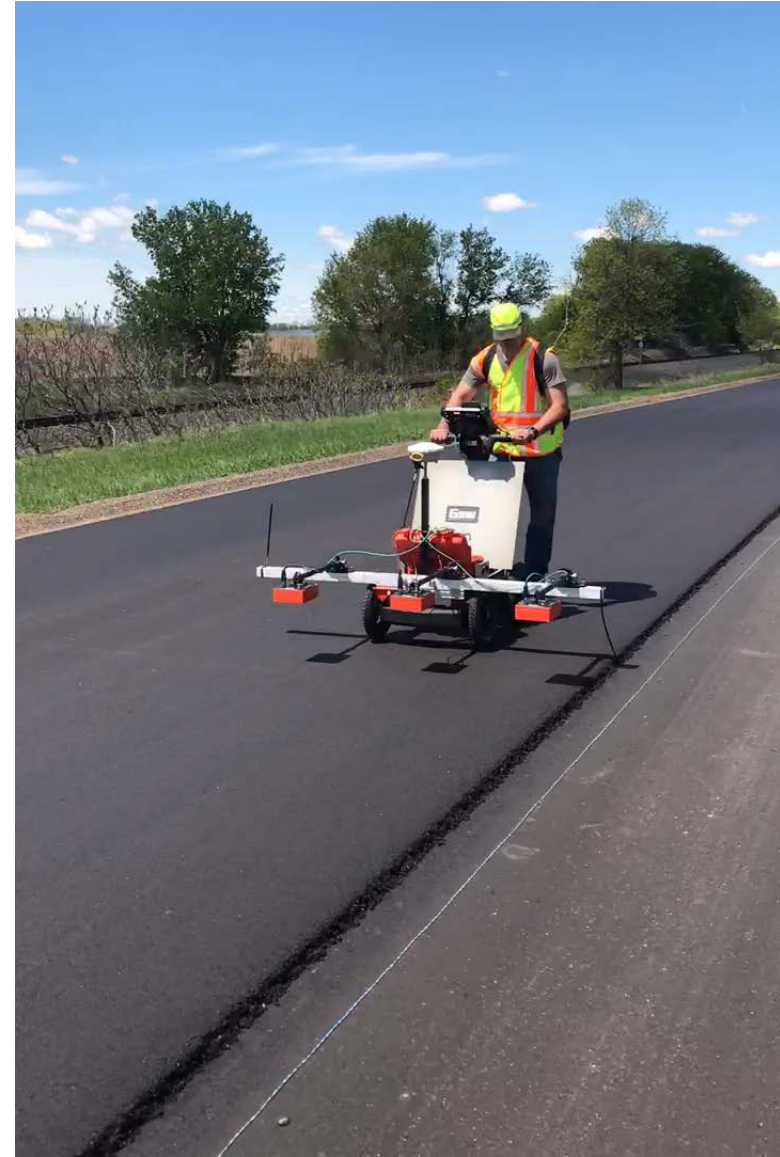
Analysis: 100% Joint Coverage

Geospatial Representation

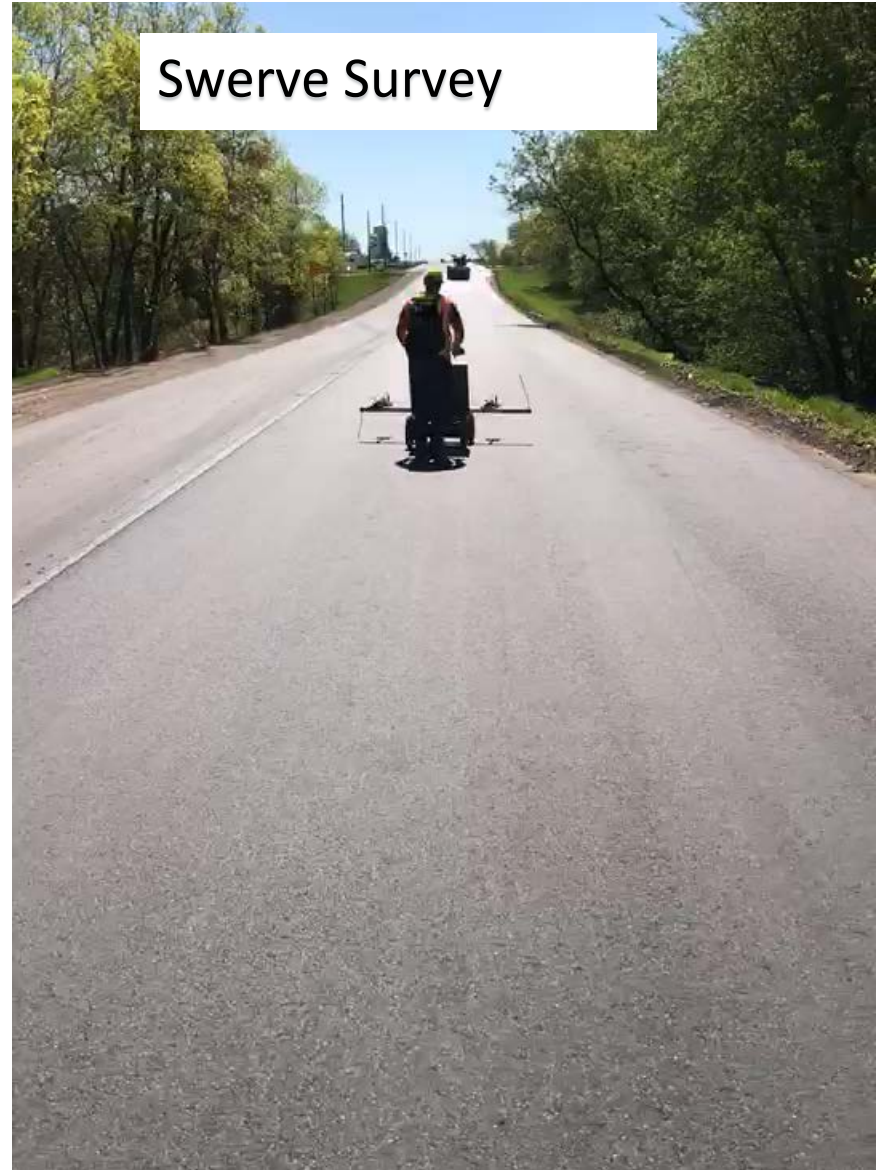
Analysis: Mat Compaction

“Random Cores on Steroids”

- Nondestructive
- Many Samples

Google Earth

Swerve Survey

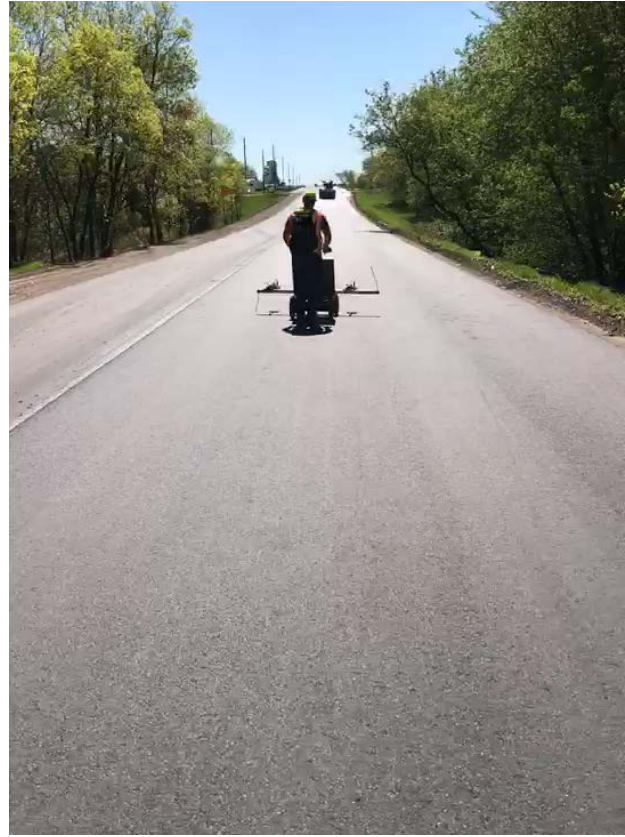
Method Overview: Field Calibration

Daily Check

Convert “Moving Nuke Gage” to Moving “Core Machine”

- Create daily dielectric to density conversion
 - Fabricate coreless calibration pucks every day of production
 - Design voids (4%), -250 grams (8-10%), -500 grams (12-15 AV%)
 - Contractor vs Agency: Good agreement 2019 on TH 61
 - Day to day variation of same mix showed very little variation
 - Coreless calibration effective at picking up changes in the mix

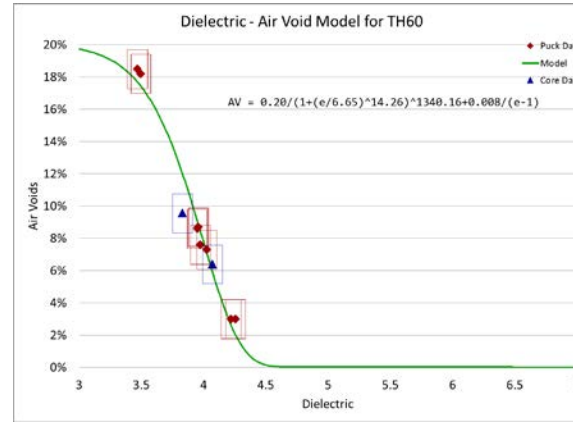
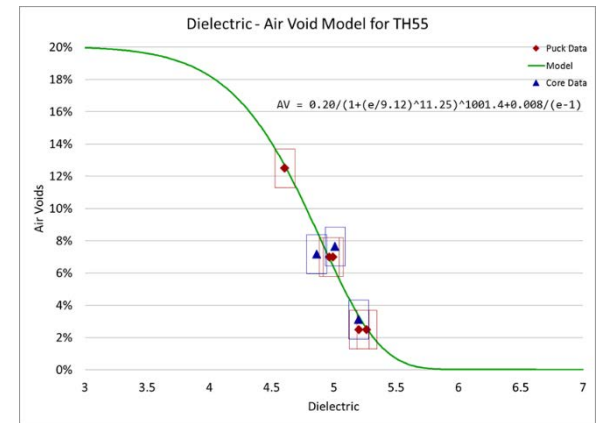
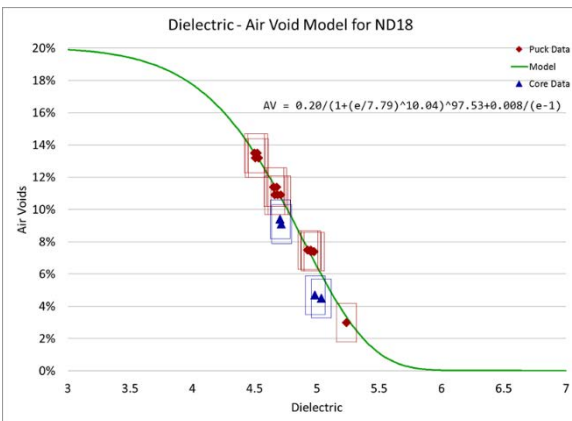
Coreless Dielectric to Air Voids

Gyratory Compacted "Puck" Coreless Calibration

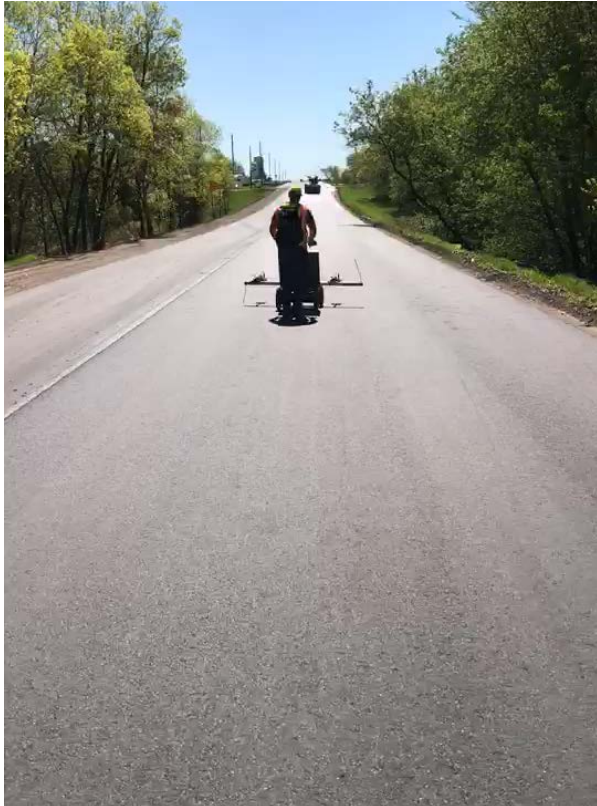
Manual Collection

- Routine collection that is accurate and not too labor intensive
